Getting to grips with slips and trips

Real workplaces, real
problems to be
overcome, real solutions
and real benefits.

Sharing experiences
from real life

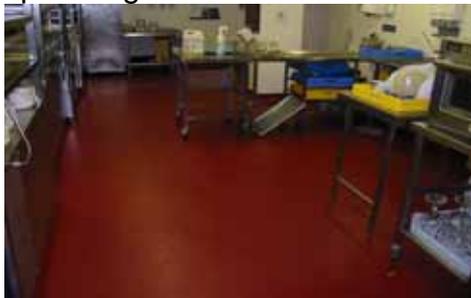
A local authority Environmental Health Officer (EHO) made a health & safety visit to a large suburban pub-restaurant and noticed that the kitchen floor felt unusually slippery. Kitchen staff confirmed that the floor covering was much more slippery than the similar 'safety' flooring that it had replaced some months earlier.

Tests by the Health & Safety Laboratory (HSL) using pendulum coefficient of friction and surface micro-roughness measurement techniques showed that the floor's slip resistance was 'borderline' when dry and unsatisfactory if wet. This was not felt to give enough grip for a kitchen where there was bound to be at least some splashing onto the floor.

resistance but eventually decided that the most effective option was to replace the floor covering. Management made sure that the new floor covering had been reliably tested for slip resistance and that it would be expected to perform well in a commercial kitchen situation.

The replacement floor (a 'safety' epoxy material with anti slip particles) was tested by HSL and the results indicated that it ought to perform well in both dry conditions and when subject to the sort of contamination that is to be expected in a busy kitchen.

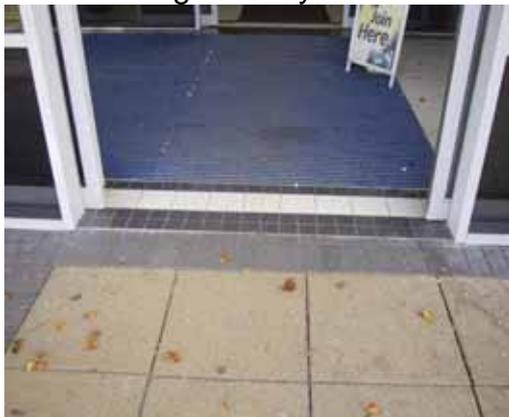
Investigations showed that these areas quickly became wet on rainy days with water being walked in on shoes through the foyer.

The entrance matting systems in place were not large enough to cope with the amount of water transferred onto the mats from pedestrian movement.

The supermarket also reviewed their store entrance matting system. The existing sunken matting was complimented by extra matting during wet conditions. In the longer term the supermarket built a canopy over the entrance to further reduce the direct ingress of water.

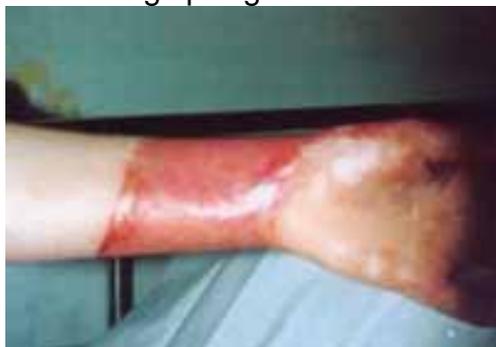
A 16-year-old girl was employed at a fast food outlet to cook fries at a frying range. She slipped on water leaking from an ice-making machine and instinctively put out her hand to break her fall. Unfortunately her hand went into the deep fat fryer containing oil at a temperature of 360°F and she sustained severe burns to her left hand and forearm.

Severe burn injury resulting from a simple slipping accident.

The ice-making machine had been leaking for several days and

various attempts had been made by different contractors to cure the leak. No one had sole responsibility to co-ordinate the repair of faulty equipment and a lack of communication between different shift managers left the equipment leaking over a long period of time.

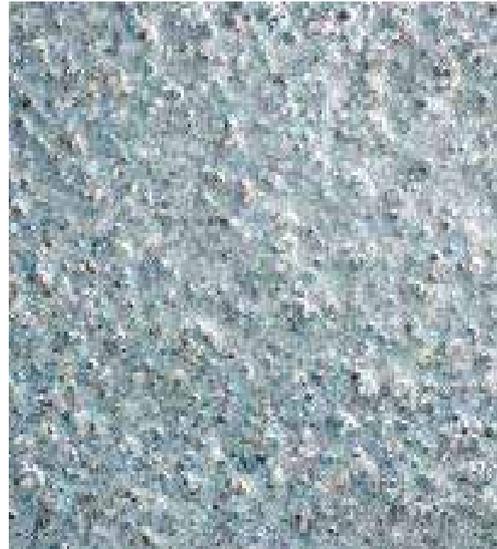
The finished floor with an even distribution of anti-slip treatment.

The health and safety manager responsible for the swimming pool was very happy with the resurfaced floor, which has been carefully maintained and using the correct cleaning regime, slipping accidents are now a rarity.

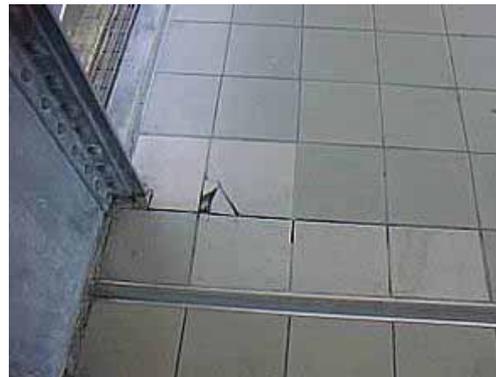
Ramped walkway surface 'before'.

Initially, railway station management arranged for the ramps to be treated with an acid etch to try to increase the slip resistance of the tiles.

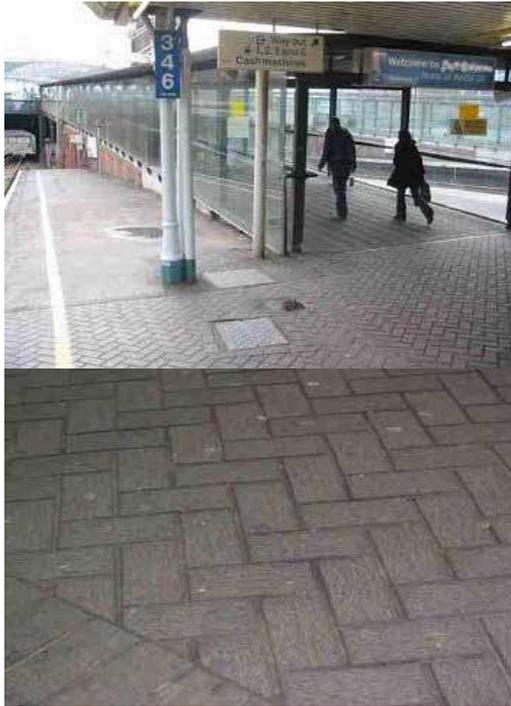
Ramped walkways after resurfacing.

This did help to reduce the number of slipping accidents. However, it was felt that more could be done. Later a second walkway surface was applied. This was an anti-slip reinforced plastic covering that was simply glued on top of the old ceramic tiled surface giving the visual effect of a brick pavior surface.

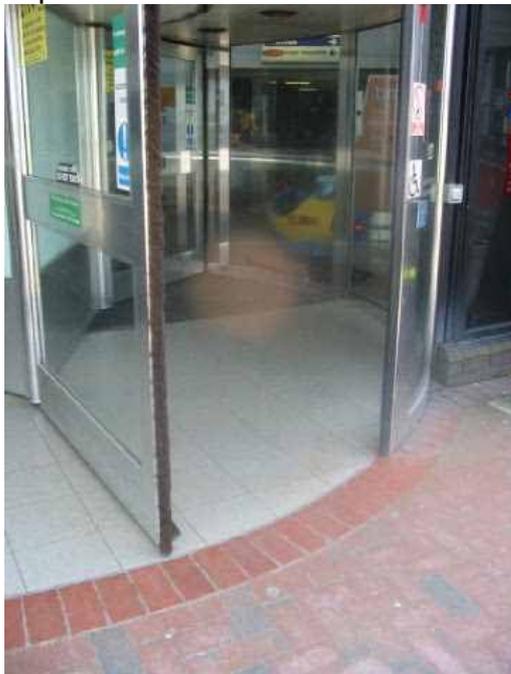
and old) are rushing, turning and distracted. Slip risk was identified as being high. The inner half of the floor within the circumference of the revolving door consists of coarse grit/dirt removal matting. Although this has some absorbent qualities its design (and heavily worn condition) render it of little use in preventing walk-in water being carried onto the adjacent concourse where control of contaminants is known to be important.

Response. Arrangements are being made to have the revolving door removed and pedestrian flow redirected to a better-controlled area. A decision made easier by the 'temperamental' nature of these particular powered doors.

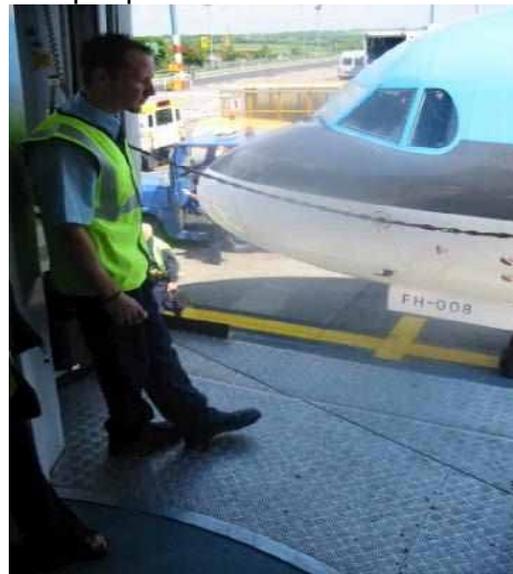
The air-bridges are floored with textured vinyl sheet for the most part and are cleaned to a high standard. Even with young and old, encumbered, rushing and distracted pedestrians the textured vinyl – protected as it is from foreseeable contamination of any significance – performs well. The last few feet of the air-bridges (where they dock with the aircraft and where the operative stands) are floored with metal chequerplate.

Experience and experimentation suggest that the slip resistance of metal chequerplate is not a direct function of the raised profiling pattern but related more closely to the microroughness of the upper surface (the foot contact surface) of each profile cleat. Microroughness measurements and analysis of the other relevant conditions indicate there is little problem if the chequerplate is kept clean and dry but that it offered poor slip

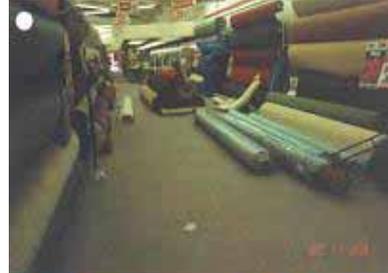
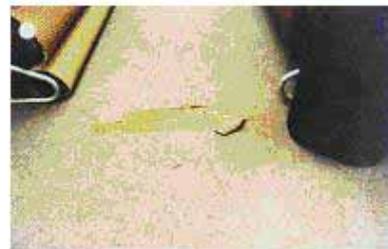
The shop floor was very congested with stock and goods were left in the main walkways. There were also areas of worn and damaged carpets in the public area. The warehouse at the rear of the premises was even more congested with stock, restricting access to the racking and obstructing the fire exit

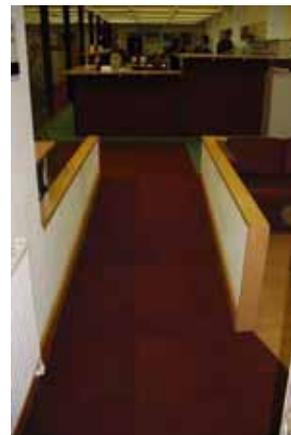
'Sloped walkway which was not apparent at first glance.'

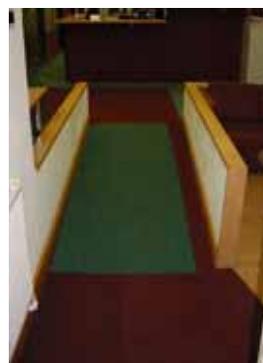
'Highlighted changes in floor level.'

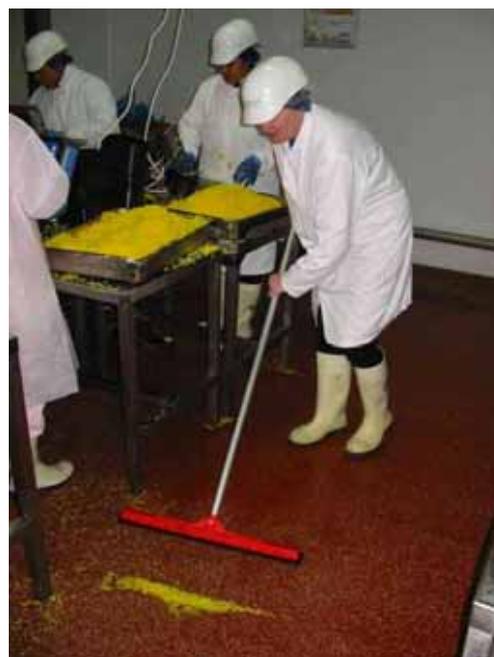
Some food spillage was inevitable.

Production lines no longer had fixed hose-pipes for swilling down as it was found that they had often been just left running resulting in a lot of water on floor surfaces and wasted money on water bills. Hoses can now be collected from the equipment stores when they are needed for cleaning down but must be returned. Instead, one person on each processing line is designated as being responsible for clearing away any food spillages as they happen. Floor contamination by water and product is now much less – so fewer slips.

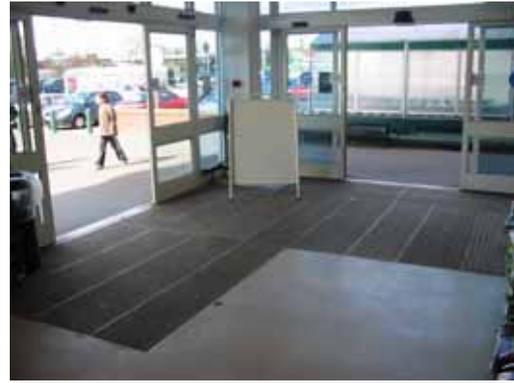
'Old style' store entrance.

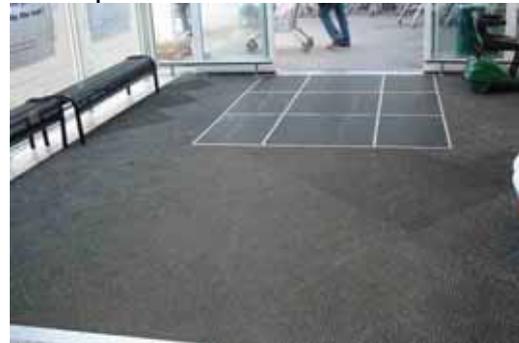
A store entrance following improvement work.
