Getting to grips with slips and trips

Real workplaces, real
problems to be
overcome, real solutions
and real benefits.

Sharing experiences
from real life

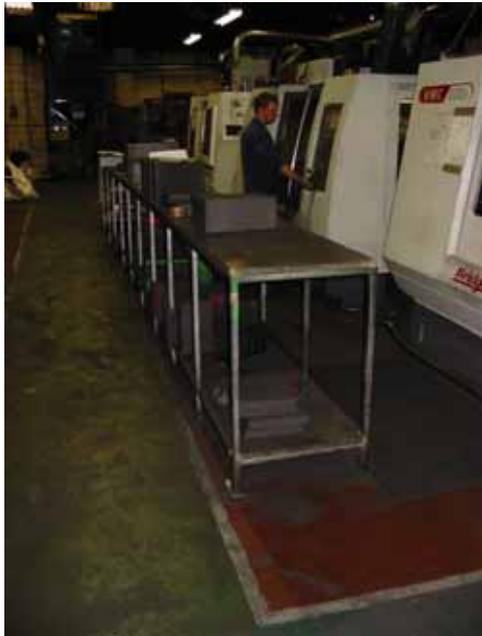
Trial treatments were carried out on various parts of the floor using epoxy paints with 'inclusions' of various sorts and particle size to give increased surface roughness and grip. The best seemed to be gritty particles in a two-part epoxy – workers found it gave secure footing whether clean or with dust on it. Tests confirmed that the surface (with about 33 microns of surface roughness) did indeed give very good slip resistance when clean and still performed well when deliberately coated with carbon dust.

Treated walkways and work areas.

The treatment was progressively extended throughout the workshop. Workers, who were somewhat sceptical to start with, quickly realised how well the treatment worked and were soon asking,

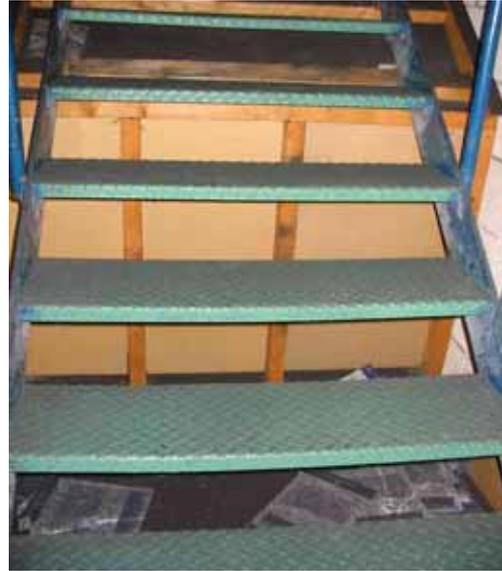
The company even found the treatment worked on profile-surfaced metal stairs that, although only occasionally used, had been said to be especially slippery when dusty.

Floor audits are carried out as part of scheduled safety checks and any areas needing attention are identified. Indications are that the service life of the 'grit paint' finish is between 12 & 48 months depending on the type and amount of use of the area. Treatment costs for the whole of the workshop worked out at around £1000.

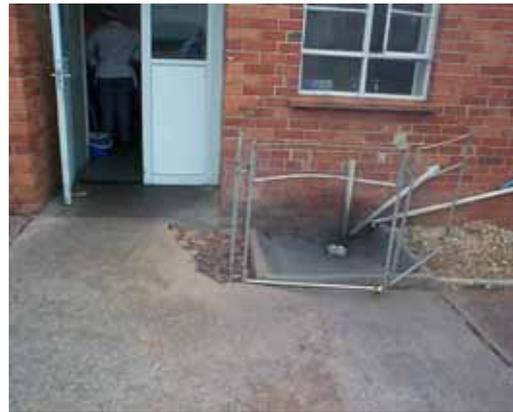
A hole had been dug in a concrete walkway at a hospital in order to repair a leak. The walkway was a busy access route to the hospital kitchen and restaurant. Five months later the hole in the walkway had still not been repaired, nor was it properly protected despite repeated requests to management from staff in the catering department.

When a catering assistant pushing a trolley tripped on the dug up walkway she fell into the shallow hole and sustained injuries that kept her off work for several months. Only after the catering assistant was injured were the necessary repairs carried out to restore the surface of the walkway.

A Health and Safety Executive Inspector investigated the accident. The Inspector concluded that the hole was an obvious and significant hazard and on a busy thoroughfare. The risk was known to the employers (the NHS trust) having been created by them and brought to their attention on a number of occasions before the incident. There was evidence of several 'near miss' or minor injury incidents involving the hole prior to the catering assistant's accident and there were indications that repair work on the walkway was deliberately delayed so that several jobs could be 'batched' together.

**Busy access route to a
hospital kitchen.**

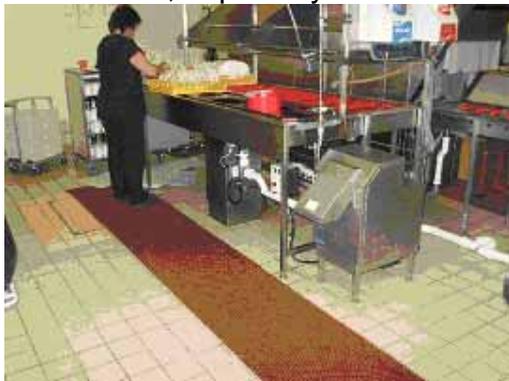
The inspector found that the tiled floor appeared to be in good condition yet it still felt slippery even when the tiles looked to be clean and dry. When just small amounts of water got onto the floor it was found to be very slippery. To make matters worse, some areas of the kitchen floor sloped, increasing the slip risk. Kitchen staff could be seen walking with a very peculiar gait to try to avoid slipping. Floor ‘safety’ mats had been put down in some parts of the kitchen, such as in the dish wash area, but these were slippery to walk on too, especially when wet.

Cleaners had removed these mats at the time of the worker’s accident, leaving her to walk on the slippery tiled floor that quickly became

contaminated with food waste, water and oily residues.

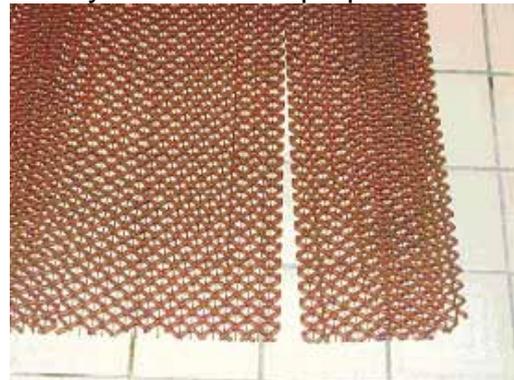
The company’s safety records examined by the Inspector showed that there had been other slip incidents in the area but the response had been to provide the most heavily contaminated areas, such as the dish was, with matting – matting that was itself slippery, especially when wet. Scientists from the Health and Safety Laboratory examined the tiled floor surface and the matting and confirmed that the Inspector was right to conclude that risk of slipping was unacceptably high because of the lack of slip resistance of the tiles and the matting. The floor surface was clearly not fit for the purpose

The company was also aware of numerous other slip accidents in similar situations at their other sites around the country. The Inspector served an Improvement Notice on the company to require them to deal with the slip risks to employees. After a number of other options were consider by the

company, but concluded to be inadequate or inappropriate, they eventually replaced the floor surface with one that was suitable for use in an area where the total elimination of floor contaminants would never be possible. The new floor was specified to provide enough grip, even in wet or contaminated conditions.

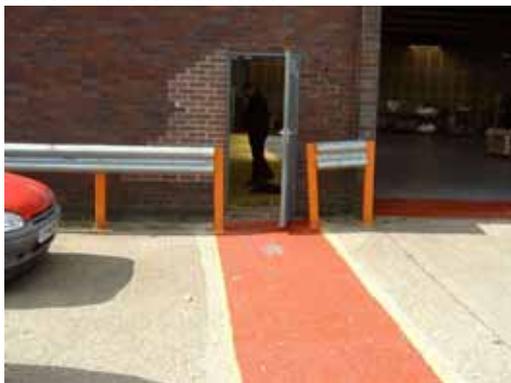
An employee arrived for work and, on finding the normal staff entrance obstructed by a pool of water and carelessly discarded cleaning equipment, had to go in through the adjacent vehicle entrance. She had no way of knowing that the paint on the floor was still wet and, quite unsurprisingly, slipped on it and fell heavily. Not only did she get covered in the wet paint but the fall broke her wrist too.

Pedestrian access route and painted vehicle access route floor.

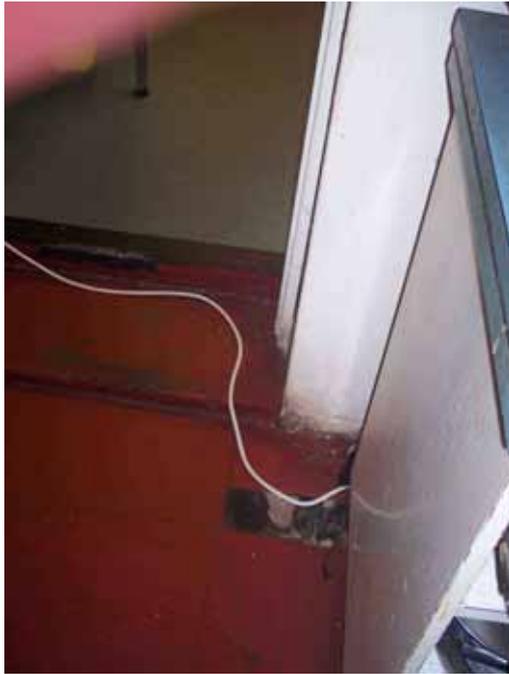
An electrical cable was seen trailing across a step. A storeroom, which had to be regularly accessed by staff to obtain items such as toilet paper and the highchair provided for customer use, was almost completely obstructed and virtually inaccessible because of the clutter of things being haphazardly stored there.

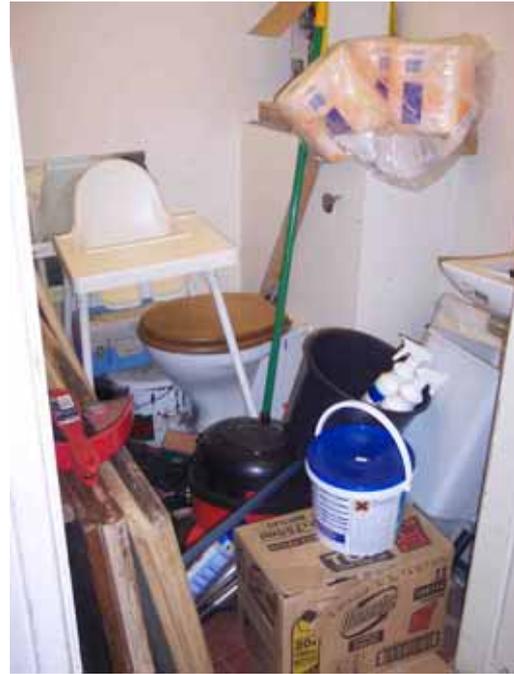
The case was heard by a District Judge who said that 'the safety of employees is imperative'. He said the tripping hazards, particularly the trailing cable, were 'an accident waiting to happen'. The proprietor was fined £1000 for this offence, compared to fines of £500 for non-compliance with Food Safety Improvement Notices and £250 for the food hygiene offences, showing the significance that the Judge gave to the tripping hazard. Full costs were also awarded to South Derbyshire District Council.

The problems in the storeroom were sorted out and the trailing cable was re-routed after the visit. The local authority's decision to take the prosecution was influenced by the impact that it would have on other duty holders through raising awareness of simple tripping hazards such as electrical cables and the importance of avoiding them.

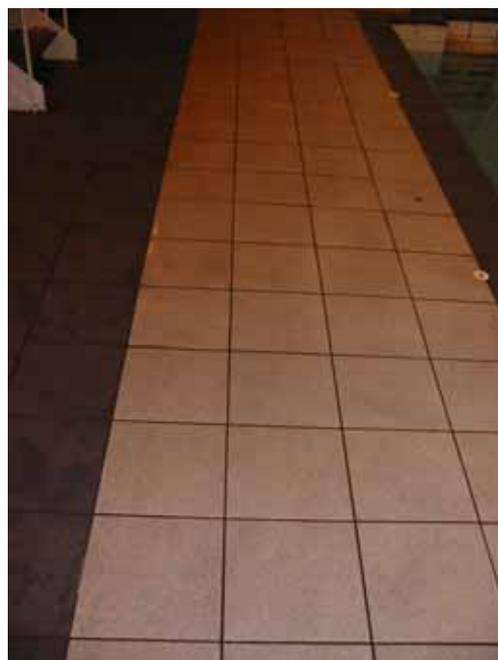
The tiled floors were rather smooth and offered little grip, especially for pool users going barefoot or the staff wearing training shoes. They were also rather old and, having had a lot of foot traffic for many years, rather worn. The clear conclusion was that something had to be done about the floors throughout these areas of the site.

surfaces to provide more grip. The manager decided against this on the grounds that upkeep of an etch-treated floor requires regular re-treatment of the tiles to maintain enhanced grip and that involves the use of chemicals for which special training and handling would be needed. He felt that he would rather avoid that if he could. He also did a costing exercise and found that the costs of the initial acid etch treatment, periodic re-treatment and the equipment needed did not seem to offer any financial savings when compared to replacing the old and worn tiles with something more suitable, especially as it proved possible to lay new and better tiles straight onto the top of the old ones. This offered a big saving on removal and preparation costs.

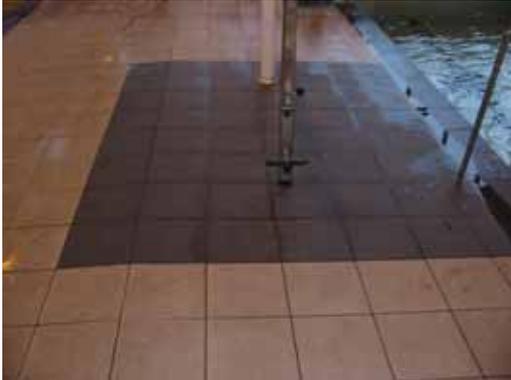
visual impairment if tiles of clearly contrasting colours or 'tactile' surface patterns were used to identify pedestrian routes, the pool edges & areas where floor mounted equipment was located.

Tiles able to satisfy the requirements for pedestrian grip and for assisting visually impaired

customers were identified and installed. Although the Inspector had the power to compel the pool owners to take action he found that he had no need to use them. The management recognised the need to sort the problem out, took the right advice and got the job done – tackling more than just the pedestrian slip risks in the process. The pool manager declared himself well satisfied with the results, the 'lift' that the look new floor gave to the appearance of the facility, setting better standards on provision for customers with disability and that the lighter coloured floor has given greater encouragement to maintaining the high standard of floor cleaning that he expects.
